**A STUDY OF STIFFNESS, RESIDUAL STRENGTH AND FATIGUE
LIFE RELATIONSHIPS FOR COMPOSITE LAMINATES**

NASA Contract Report CR-172211

**J.T. Ryder
F.W. Crossman**

LOCKHEED-CALIFORNIA COMPANY
A Division of Lockheed Corporation
Burbank, California 91520

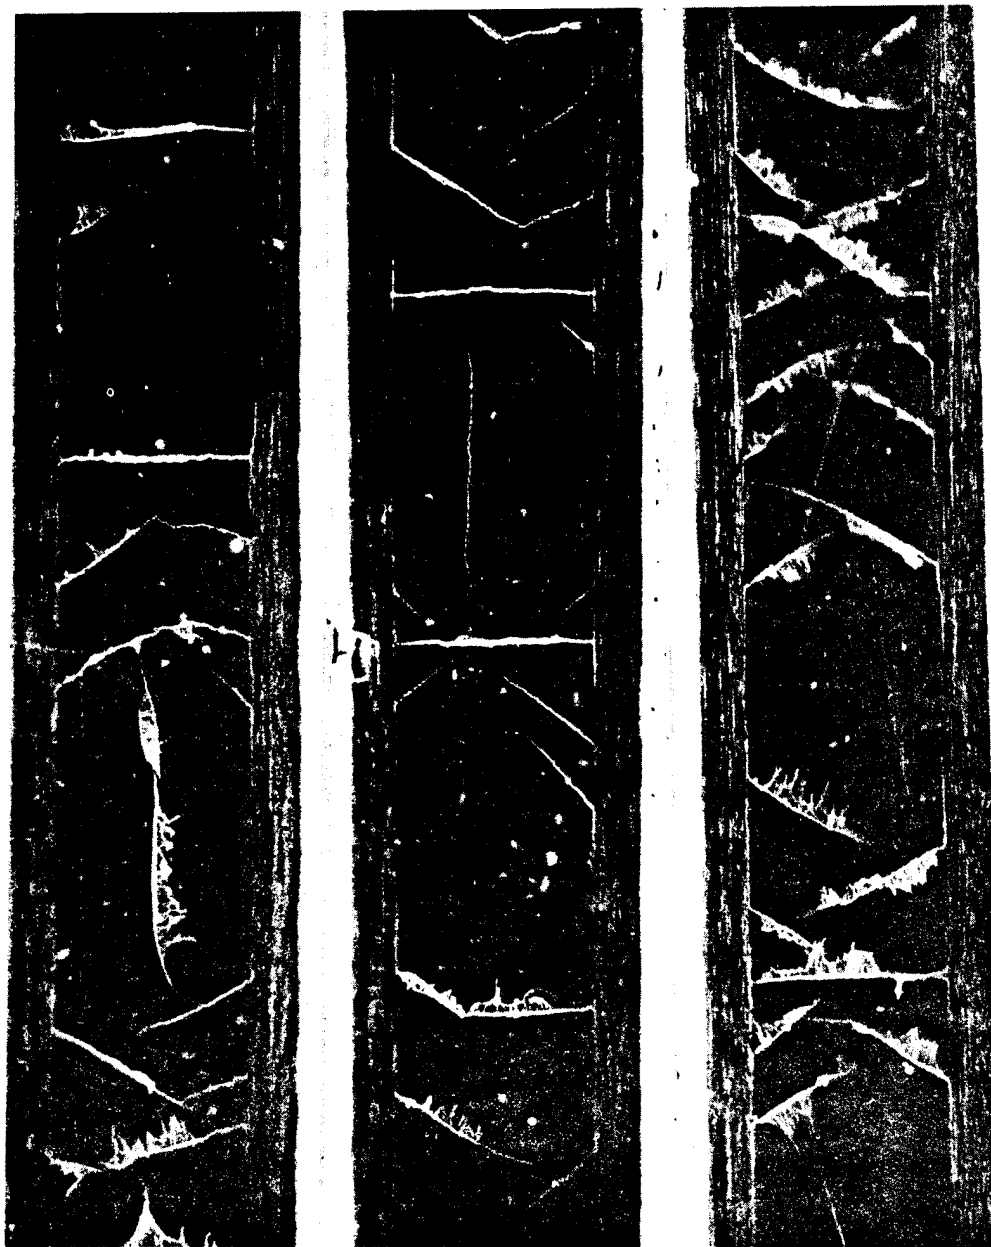
Figure 36: Transverse matrix crack patterns found in Coupon A3 at 0.00975 strain.

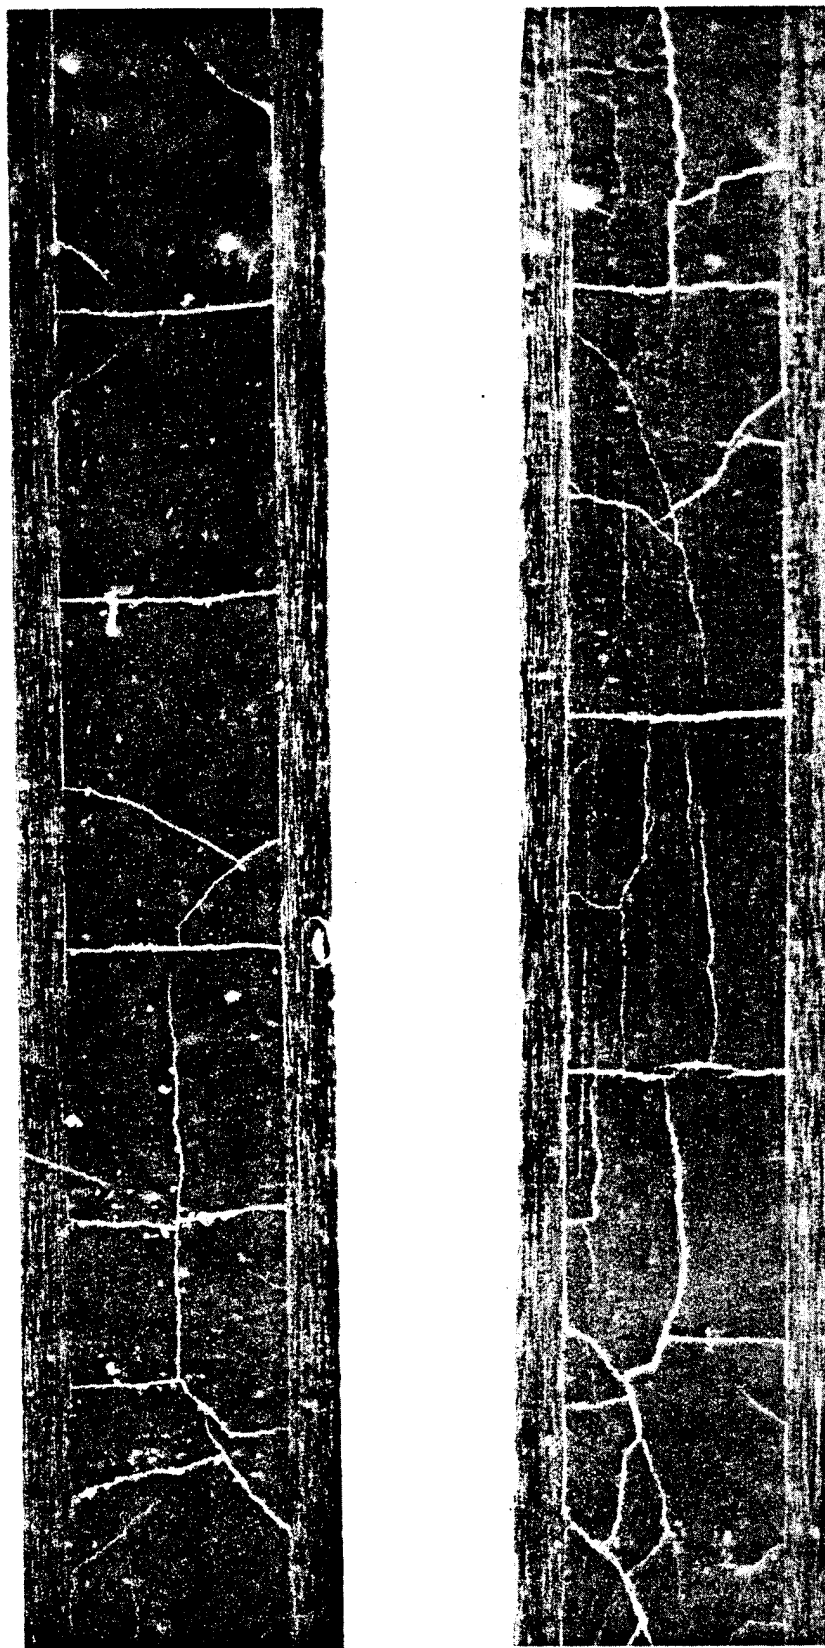
Figure 37: Edge delamination regions found on $(0_2/90_4)_s$ coupon A8 after 50 000 fatigue cycles.

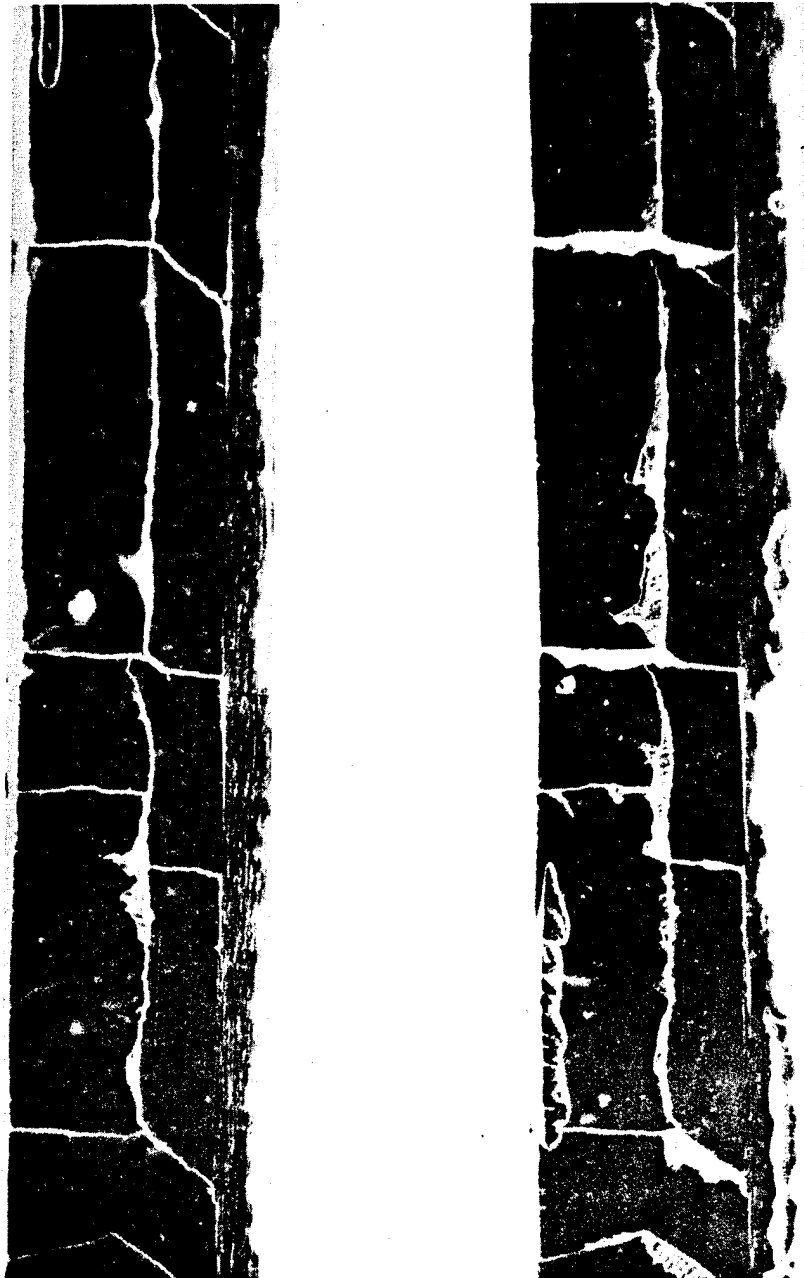
Figure 38: Edge replicates of same location of coupon A6 fatigue
cycled at $\epsilon_i = 0.006$.

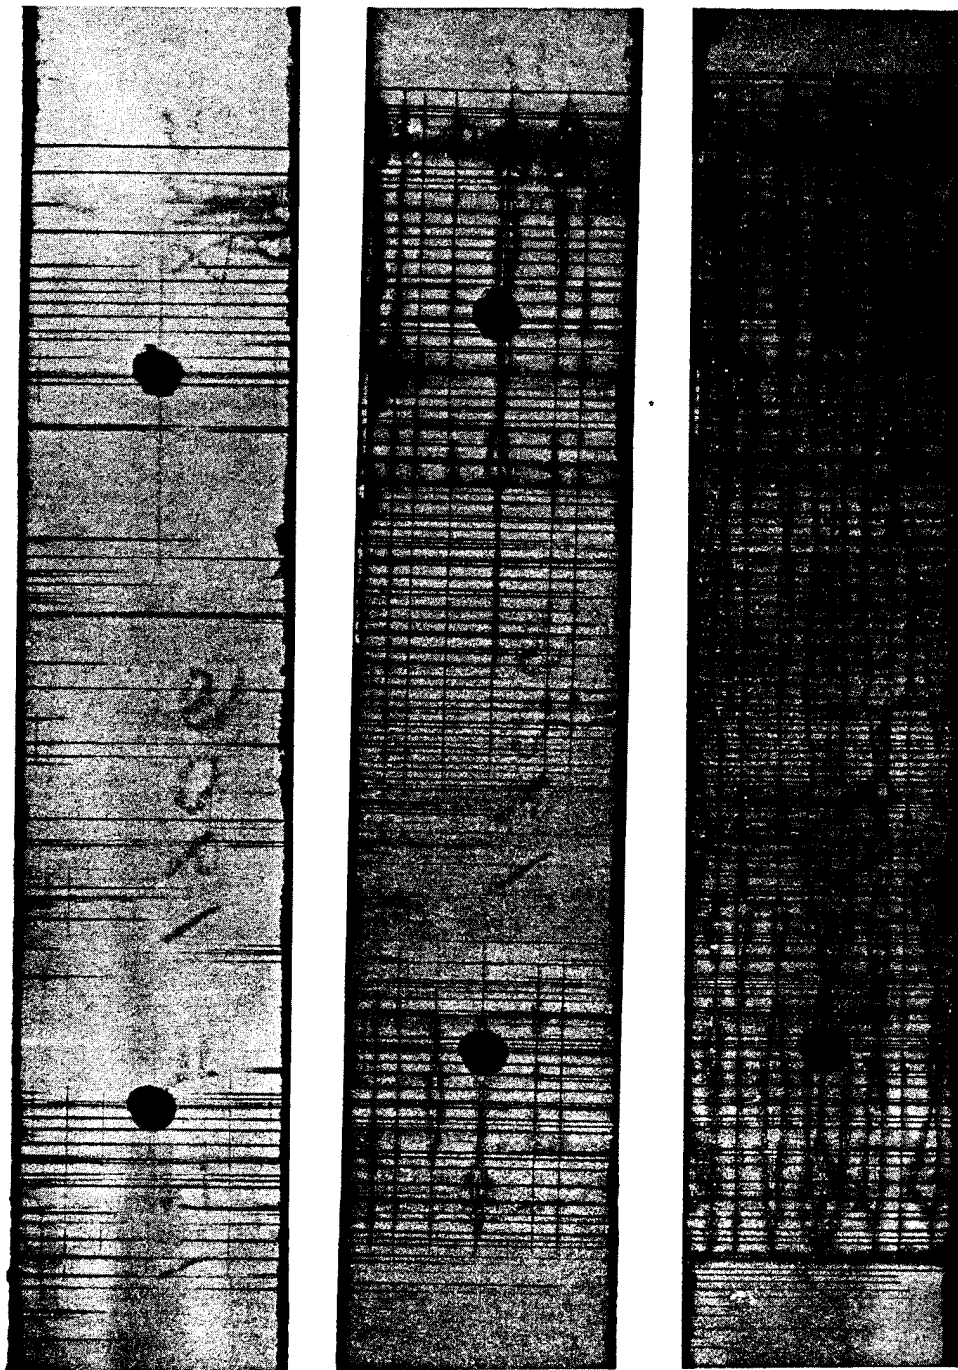
Figure 39: Enhanced x-ray photographs of coupon A6 showing 90° matrix cracking, 0° splits, and delamination; Initial $\epsilon = 0.006$.
